S-291  
Clement Sterling House  
Bedsworth vicinity  
private

c.1840 - 1850

# Maryland Historical Trust State Historic Sites Inventory Form

Survey No. S-291

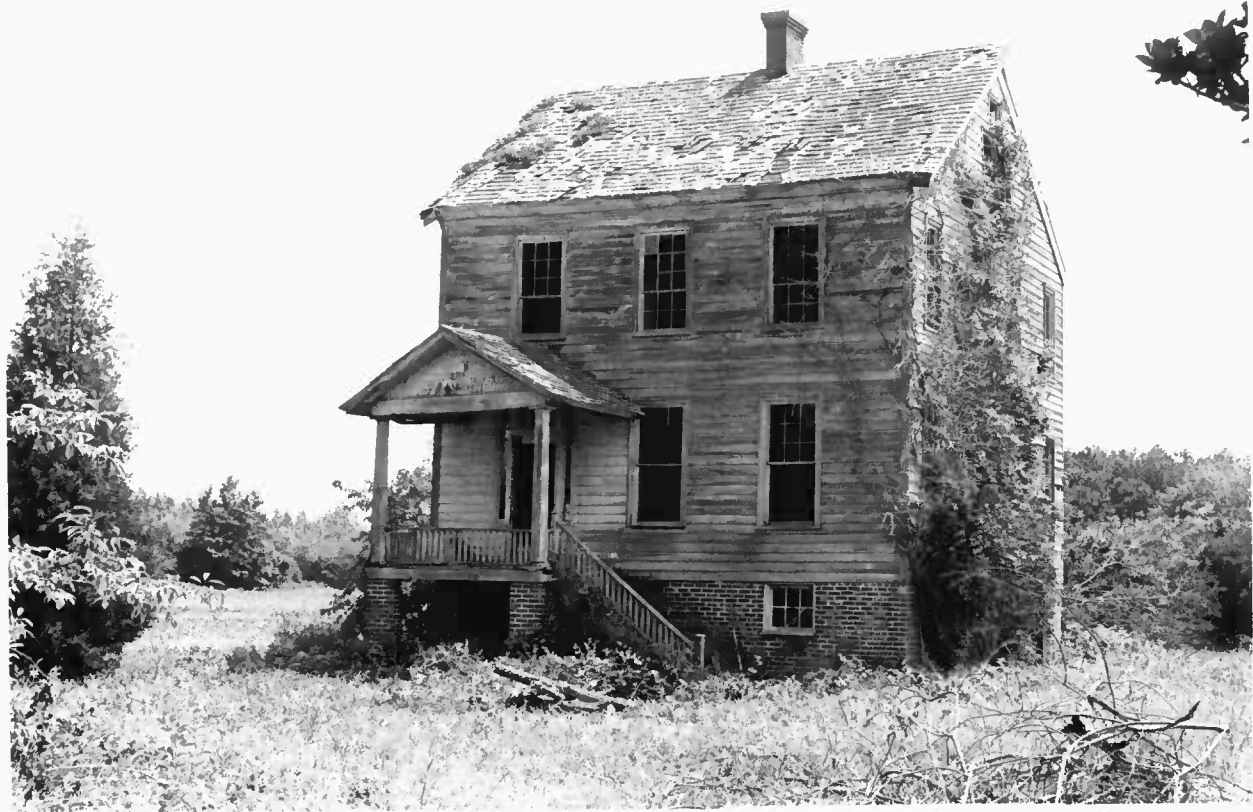
The west (main) elevation is three bays across with an entrance in the north bay. The foundation wall is pierced by six-pane windows while the first floor is lighted by large size nine over nine sash windows, and the second floor is pierced by nine over six sash windows. The glazed front door is framed by six-pane sidelights and a three-light transom. The entrance bay is covered by a gable roofed stoop supported by Tuscan columns and sheathed with fishscale shingles. Access to the elevated porch was provided by a square post handrail which has almost collapsed. The boxed cornice above the second floor windows is trimmed with a bed molding.

Clement Sterling House                      S-291  
Bedsworth Vicinity, Somerset County  
West Elevation  
8/85, Paul Touart, Photographer  
Neg./Md. Historical Trust

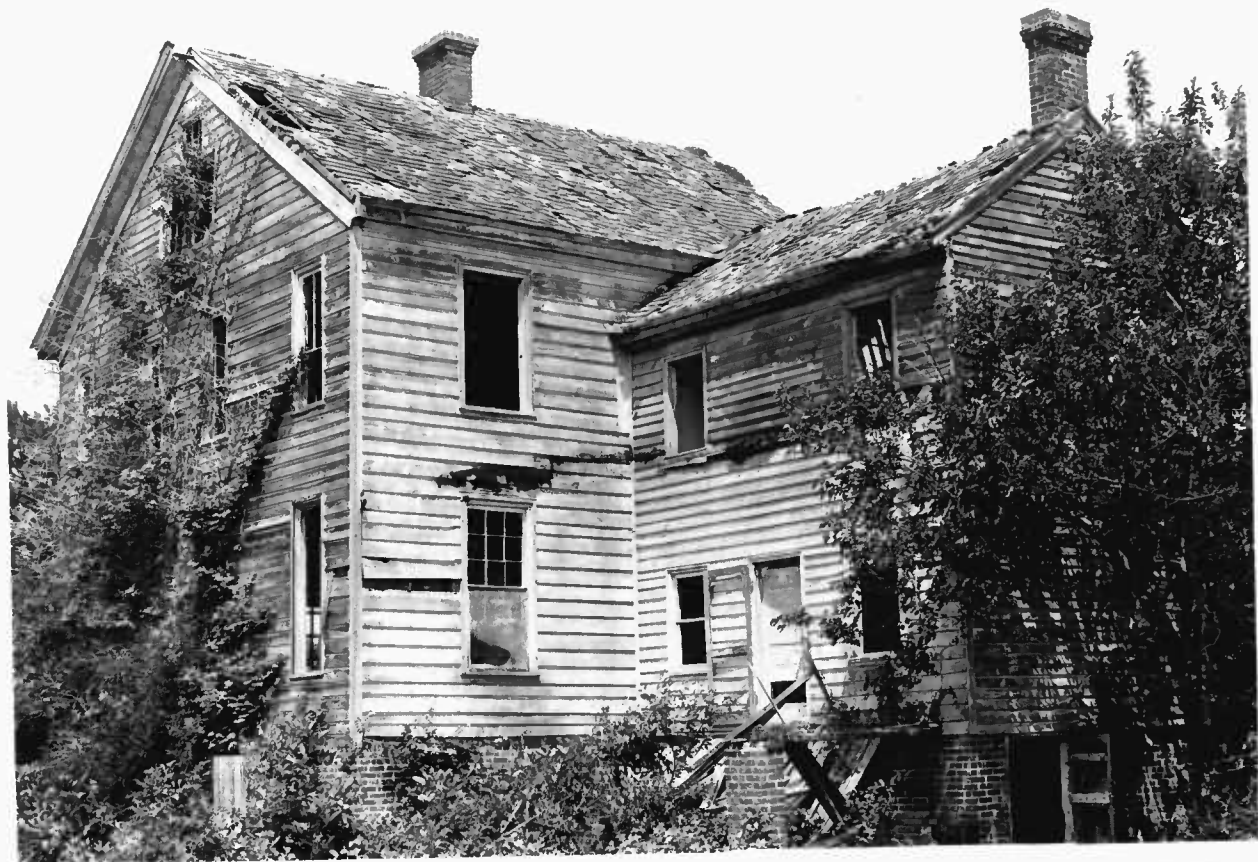
Extending to the rear is a two-story kitchen wing, three bays across and one room deep. The south side was formerly covered by a side porch on brick piers, but it has fallen in. A center five-panel door is flanked by six over six sash windows on the first floor, whereas the second floor is lighted by two six over six sash windows. The cornice is boxed and trimmed with a Greek Revival period bed molding. The east gable end of the kitchen has a board and batten door entering into the cellar, while an interior end chimney rises from the gable end. The north side of the kitchen is similarly detailed.

Clement Sterling House                      S-291  
Bedsworth vicinity, Somerset County  
Southeast Elevation  
8/85, Paul Touart, Photographer  
Neg./Md. Historical Trust

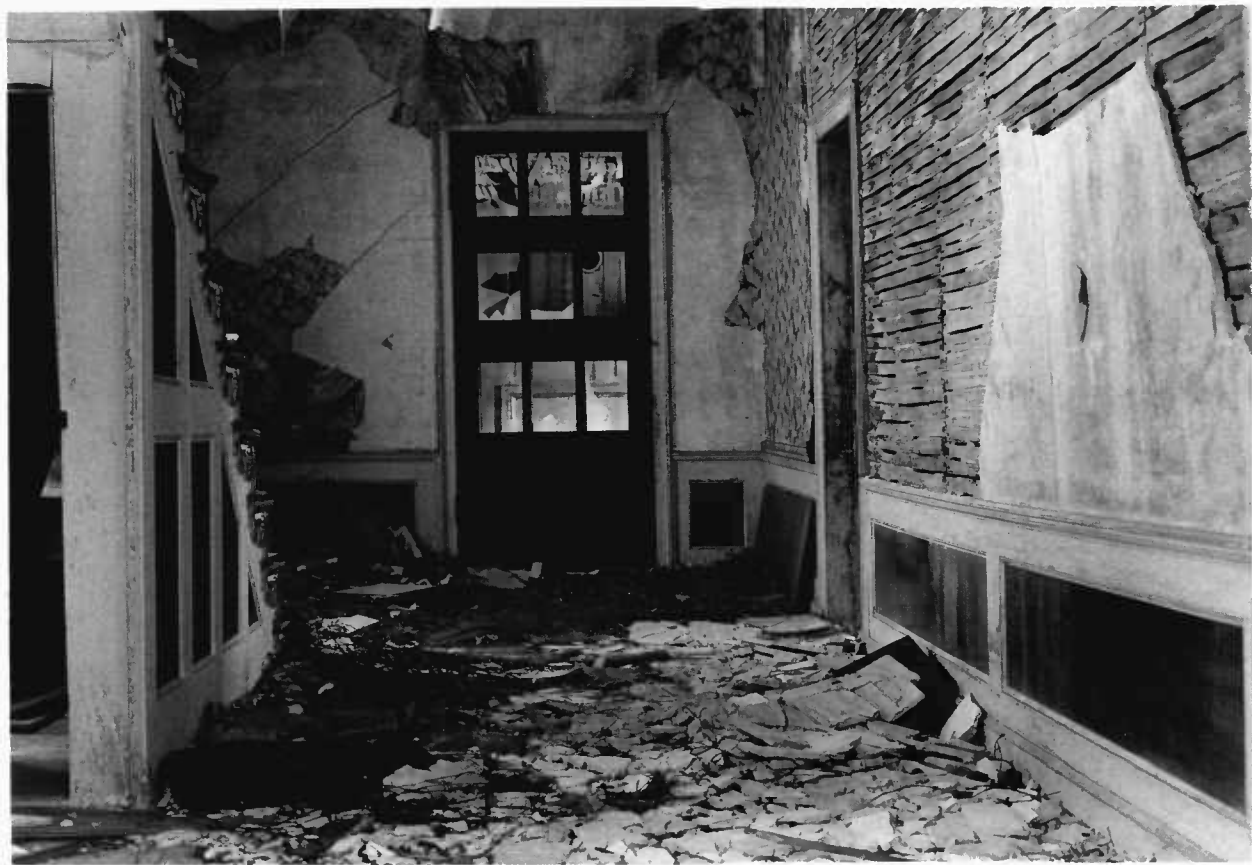
The first floor interior of the main block is divided into three rooms with a spacious side hall and two rooms to the south. Each first floor room is fitted with flat-panel wainscoting, chair rail, and baseboard. Consistent throughout the house is the paint scheme of the wainscoting. Each wainscot panel is finished in a mahogany

grain while the posts and stiles were painted in a tiger maple stripe. The baseboard is finished in dark grey or black. The stair is located against the north wall and is distinguished by scrolled decoration on each step end and a paneled stair box below the stringer. The newel post and balustrade have been removed. A flat four-panel door opens into the space beneath the stair.

Clement Sterling House                      S-291  
Bedsworth vicinity, Somerset County  
Side Hall  
8/85, Paul Touart, Photographer  
Neg./Md. Historical Trust

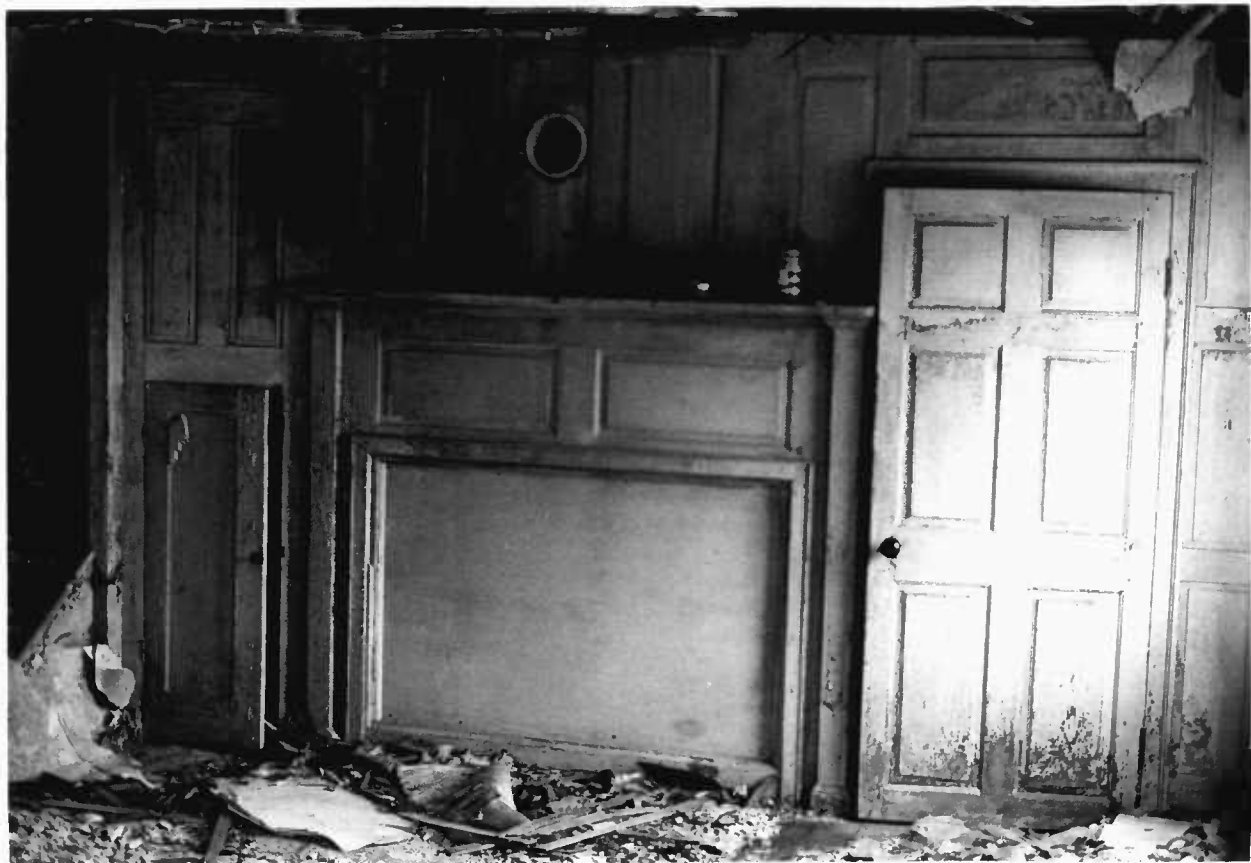
The one-room plan kitchen is distinguished by a paneled hearth wall as well as an enclosed winder stair and built-in cupboard. The plain Federal period mantel has simple pilasters, a two-panel frieze and a plain board shelf. The overmantel paneling consists of four raised panels with a cupboard door worked into the far left panel. To the right of the hearth a raised six-panel door opens into a closet. In contrast to the other doors in the house this raised panel design is a much earlier form and appears to have been reused. The enclosed stair rises to the left of the hearth behind a four-panel door, and a single-panel door opens into the stair closet. Similar to the rest of the house the kitchen has flat-panel wainscoting and molded chair rail and baseboard.

Clement Sterling House                      S-291  
Bedsworth vicinity, Somerset County  
Kitchen Paneling  
8/85, Paul Touart, Photographer  
Neg./Md. Historical Trust

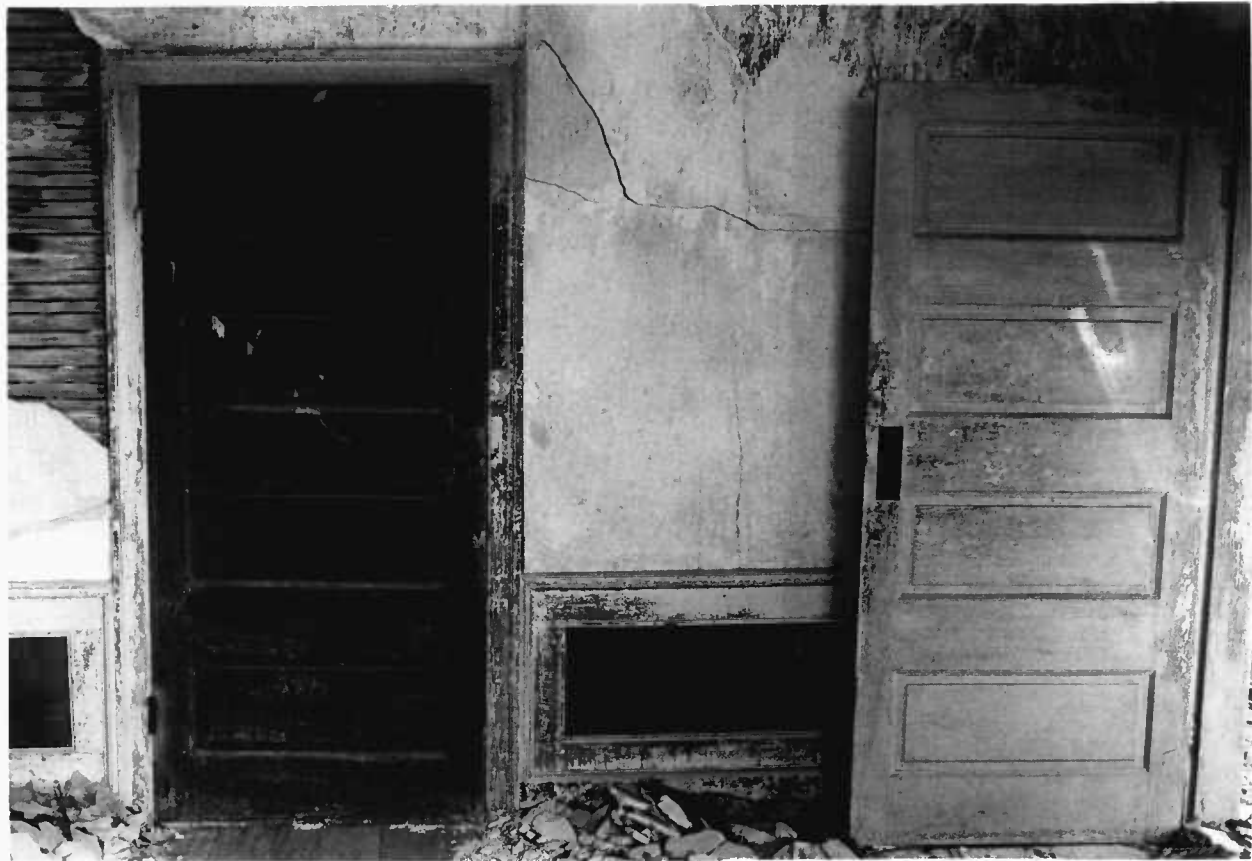
Behind the parlor is the apparent dining room which is finished in a similar manner to the parlor. However, the dining room does have a late Federal period mantel with simple pilasters, a paneled and grained frieze and a stepped mantel shelf. The old hearth opening is covered with a grained panel. Located to the right of the mantel is a glazed door cupboard, and to the left are three small single-panel chimney breast cupboard doors. An identical patch in the flooring and seams in the plaster and wainscoting indicate the size and location of the former chimney stack. A four-panel door pierces the rear wall of the dining room and provides passage to the kitchen.

Clement Sterling House                      S-291  
Bedsworth vicinity, Somerset County  
Dining Room Doors  
8/85, Paul Touart, Photographer  
Neg./Md. Historical Trust

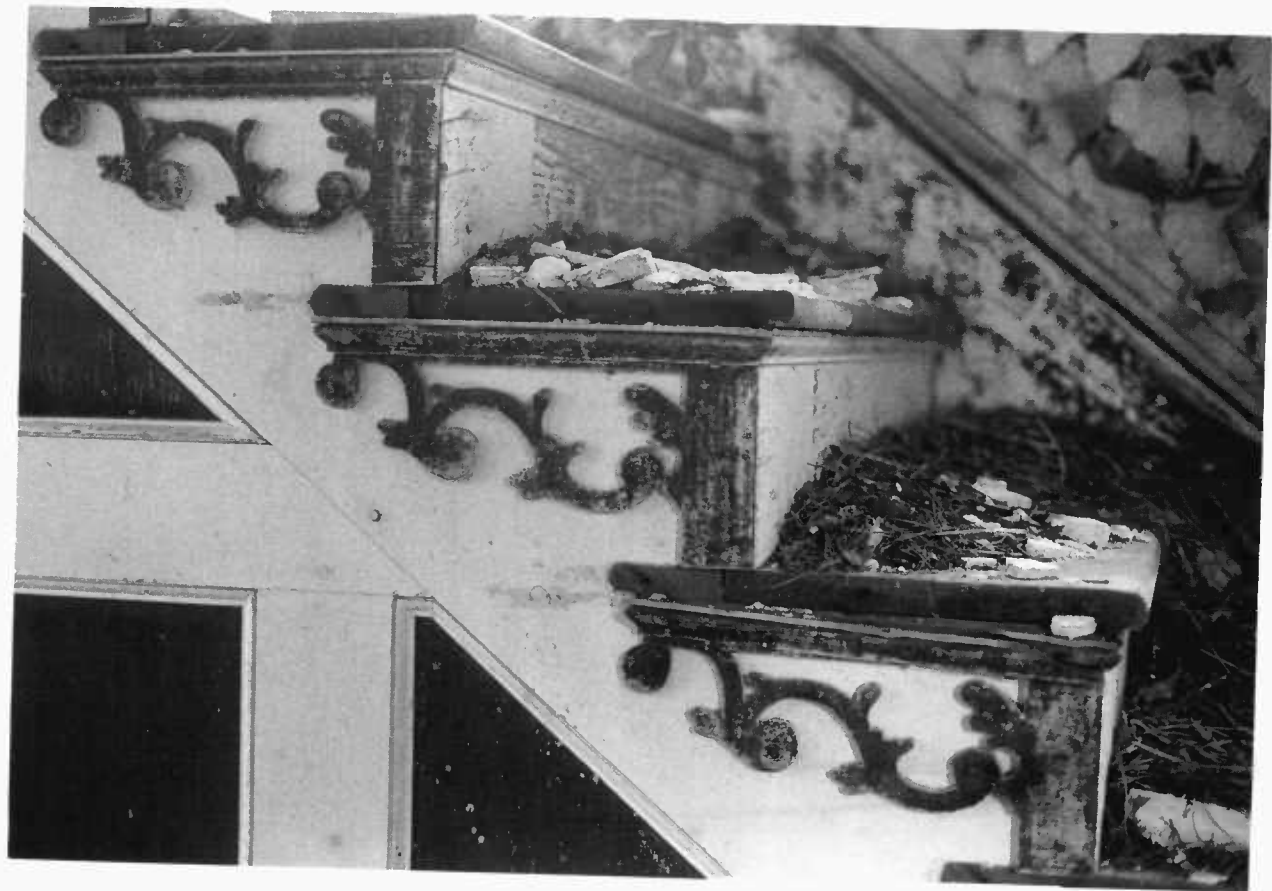
Clement Sterling House            S-291  
Bedsworth vicinity, Somerset County  
Stringer Decoration  
8/85, Paul Touart, Photographer  
Neg./Md. Historical Trust

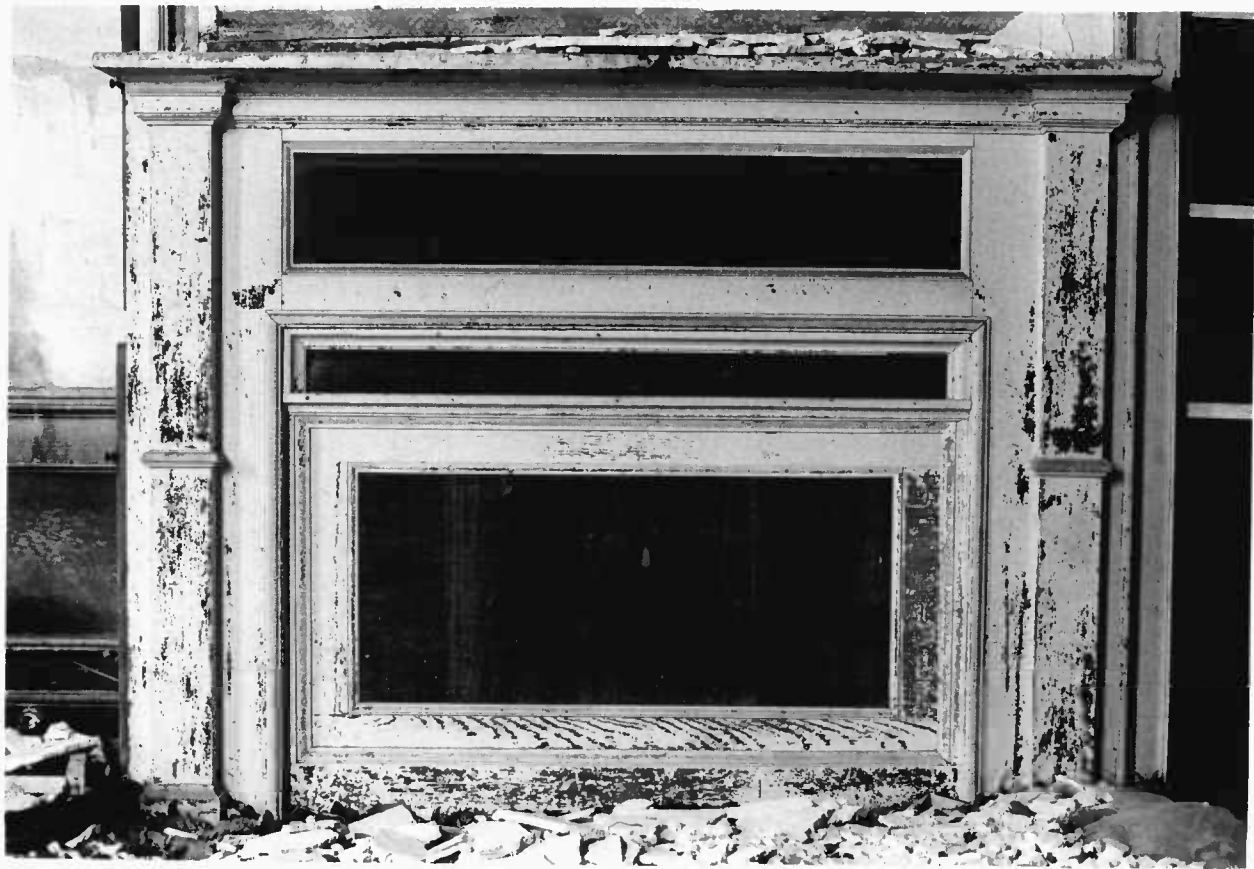
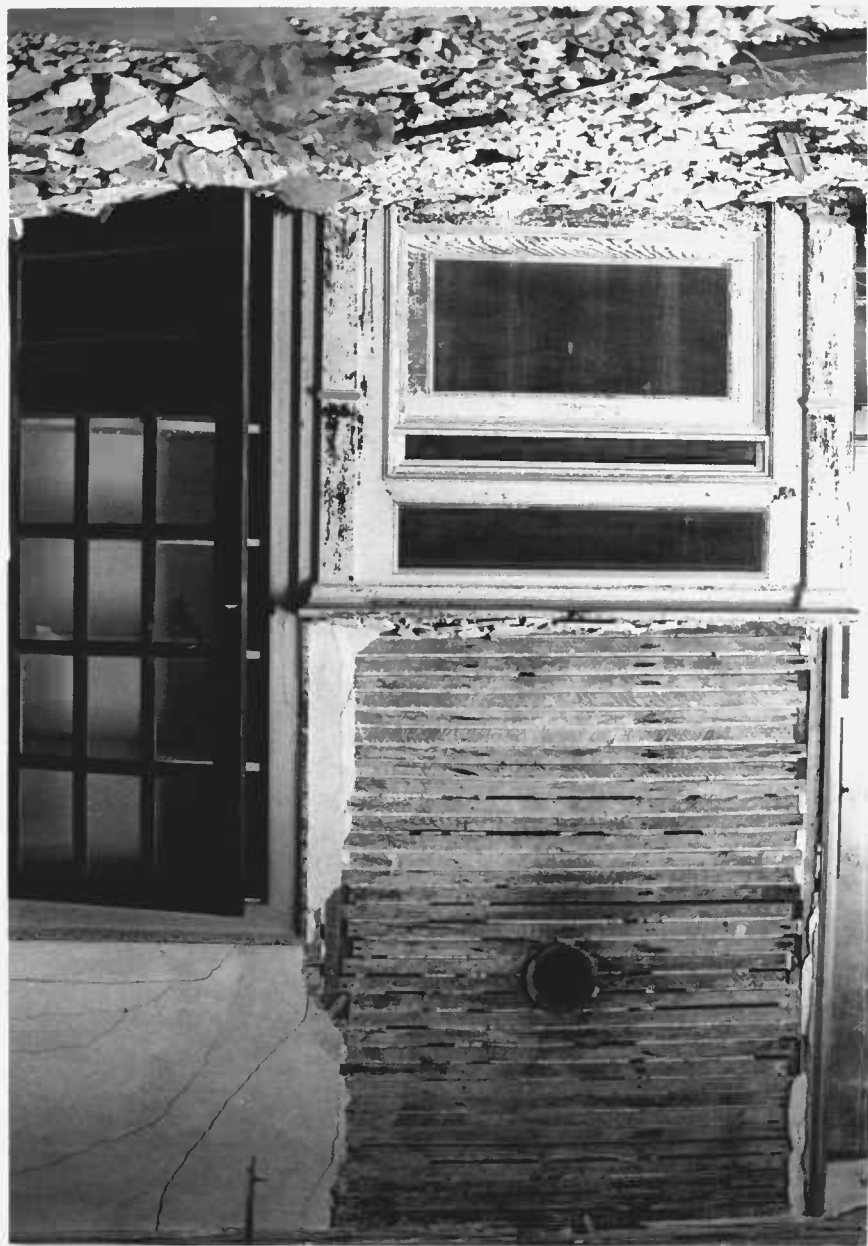
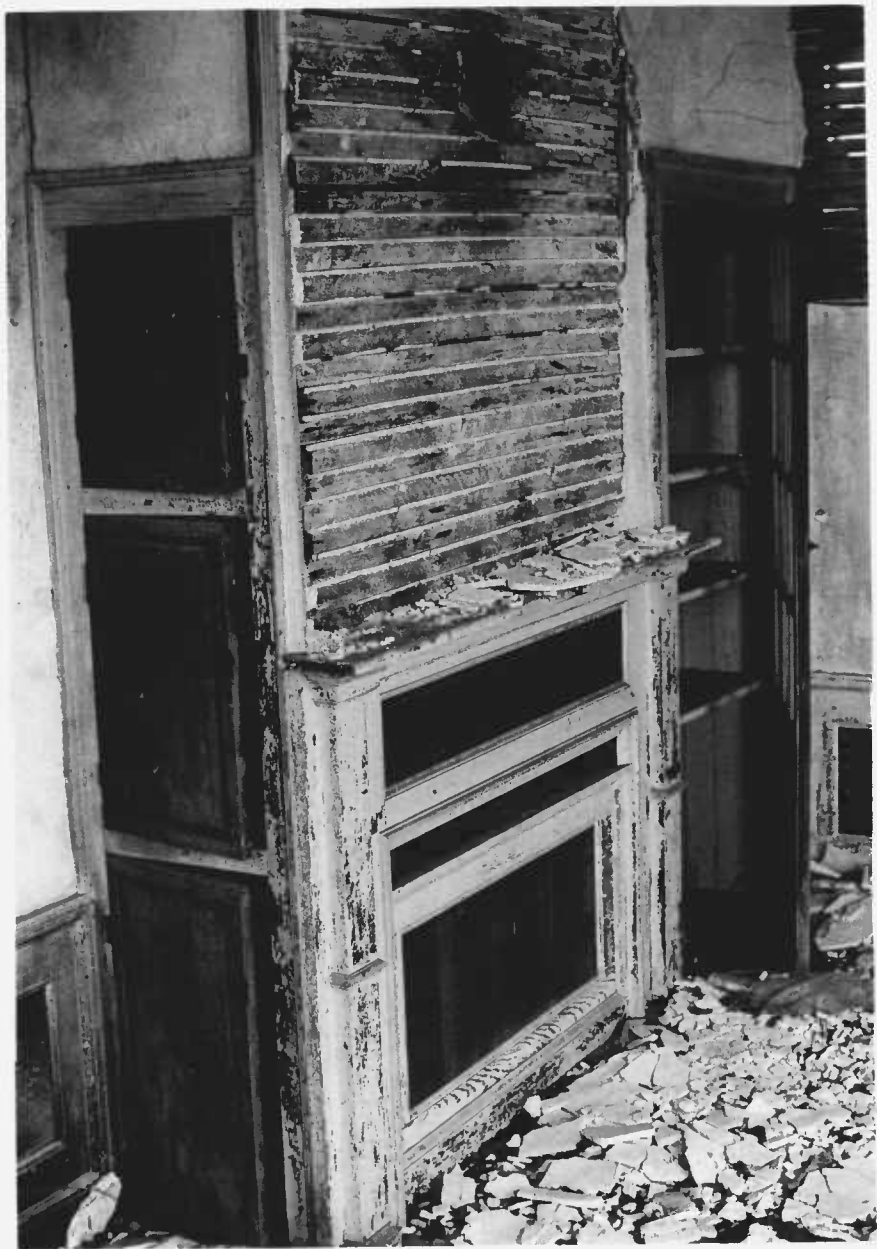
Clement Sterling House                      S-291  
Bedsworth vicinity, Somerset County  
Dining Room Mantel  
8/85, Paul Touart, Photographer  
Neg./Md. Historical Trust

Clement Sterling House            S-291  
Bedsworth vicinity, Somerset County  
Dining Room Mantel  
8/85, Paul Touart, Photographer  
Neg./Md. Historical Trust

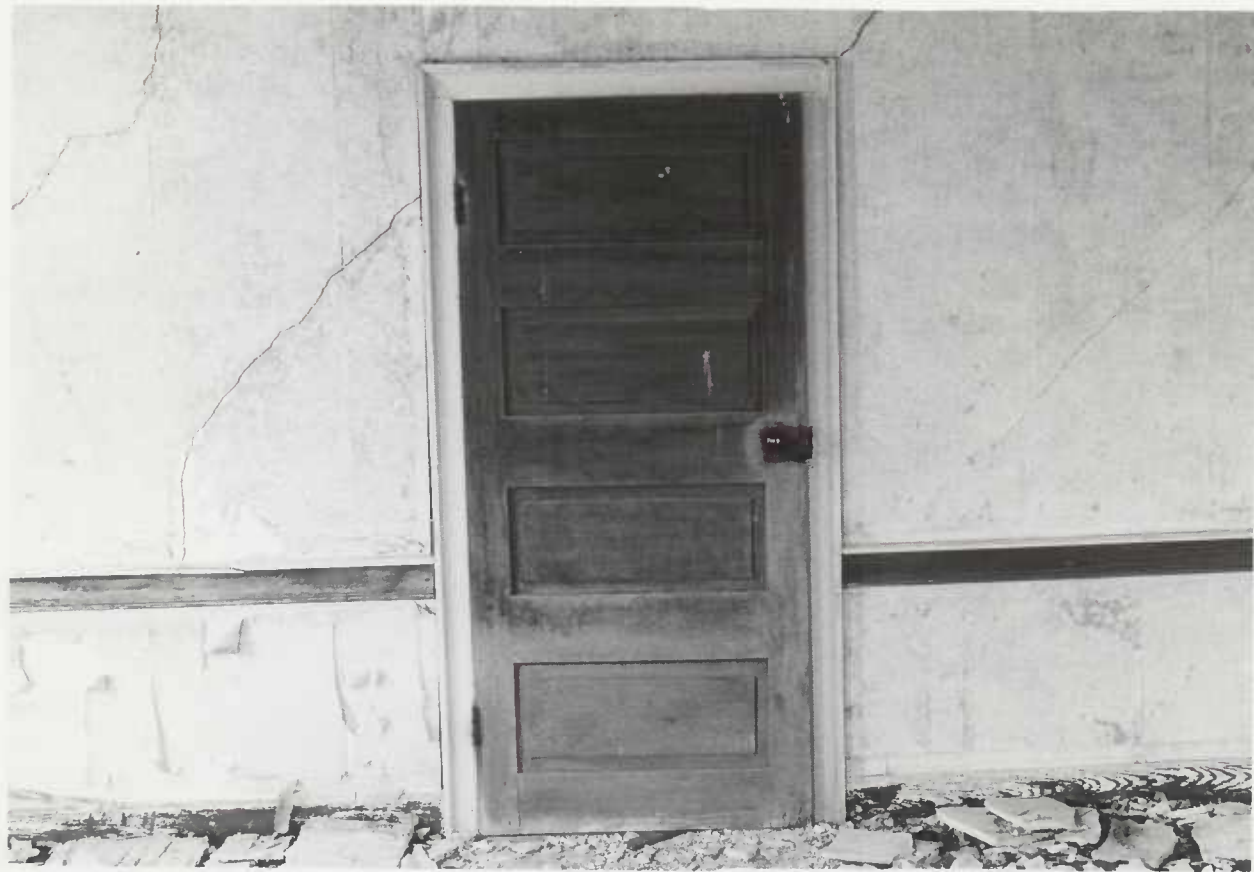
Clement Sterling House                      S-291  
Bedsworth Vicinity, Somerset County  
Five-Panel Door  
8/85, Paul Touart, Photographer  
Neg./Md. Historical Trust

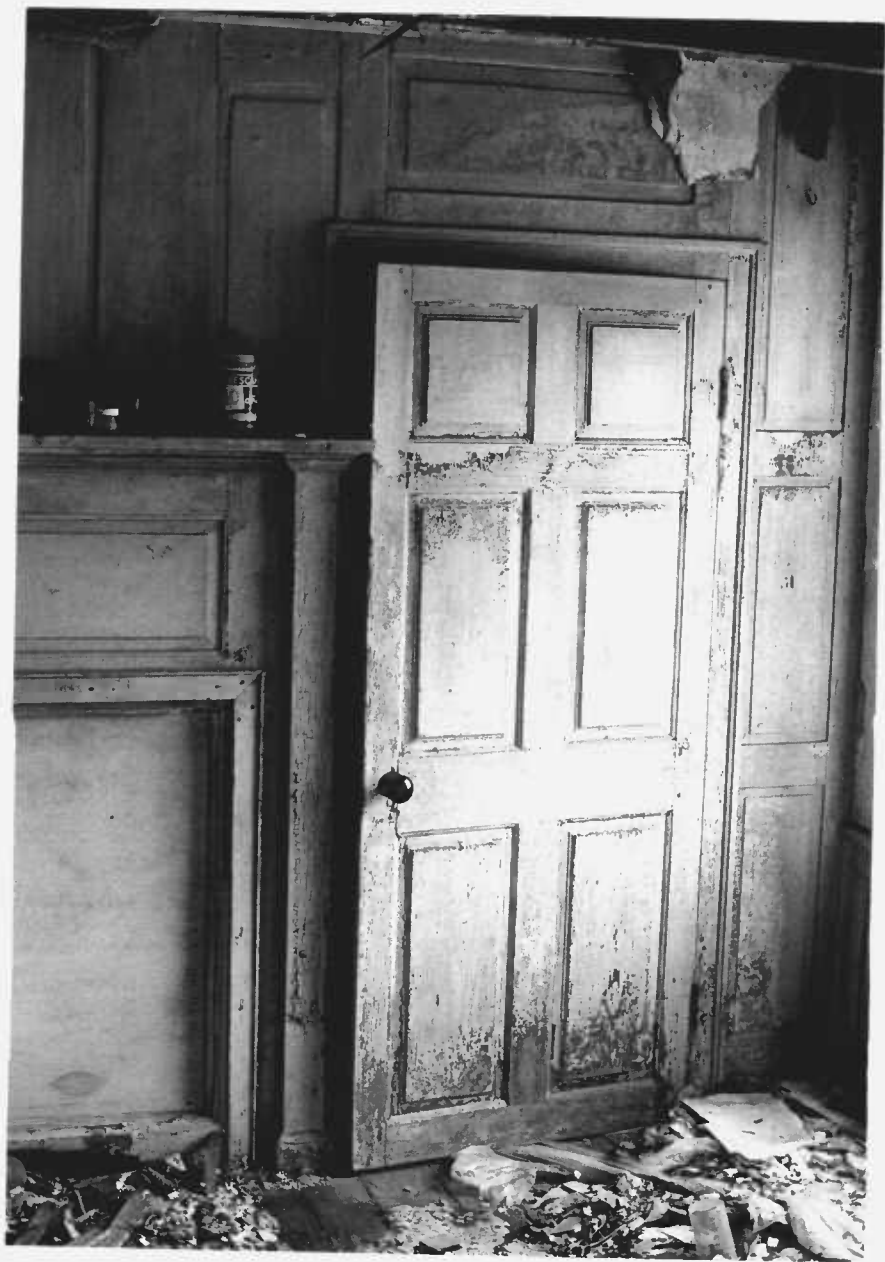
Clement Sterling House                      S-291  
Bedsworth vicinity, Somerset County  
Six-Panel closet door  
8/85, Paul Touart, Photographer  
Neg./Md. Historical Trust

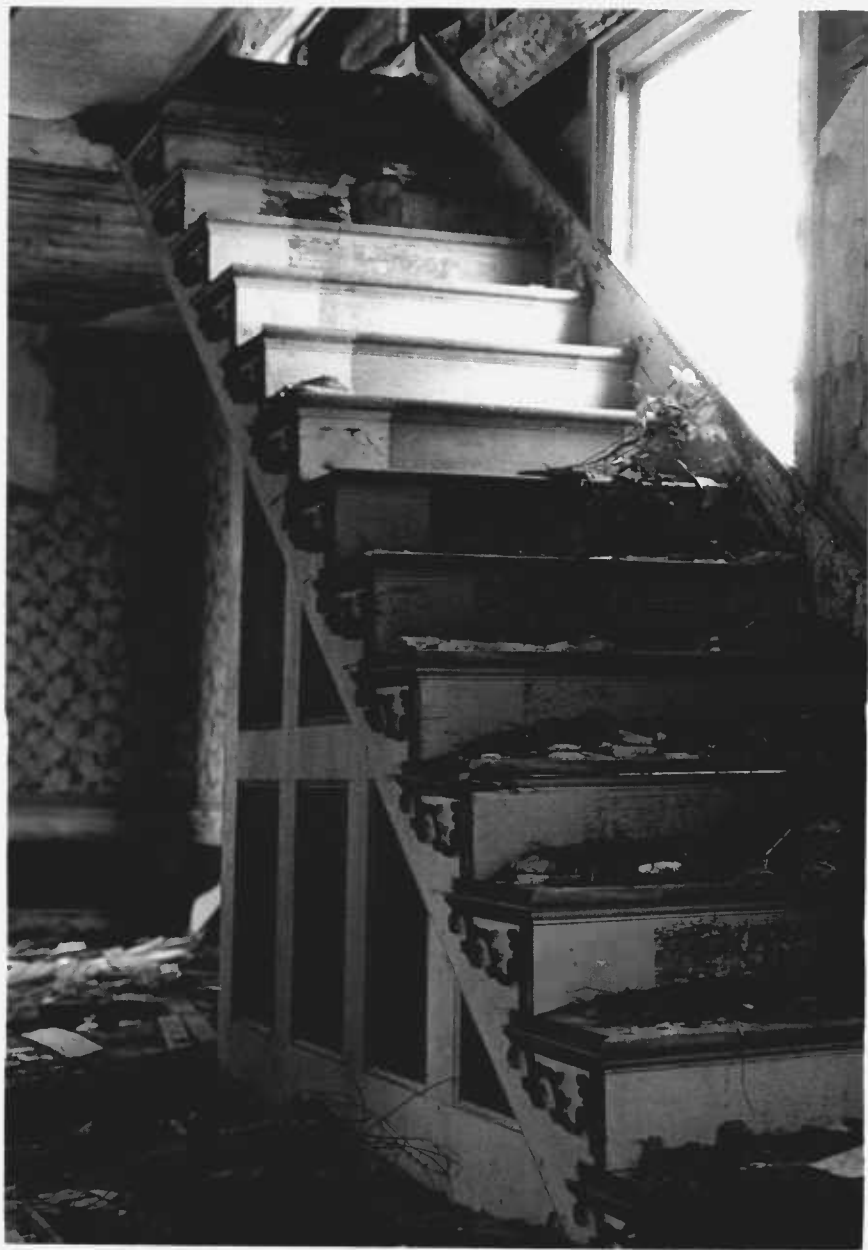
Clement Sterling House                      S-291  
Bedsworth vicinity, Somerset County  
Side Stair  
8/85, Paul Touart, Photographer  
Neg./Md. Historical Trust

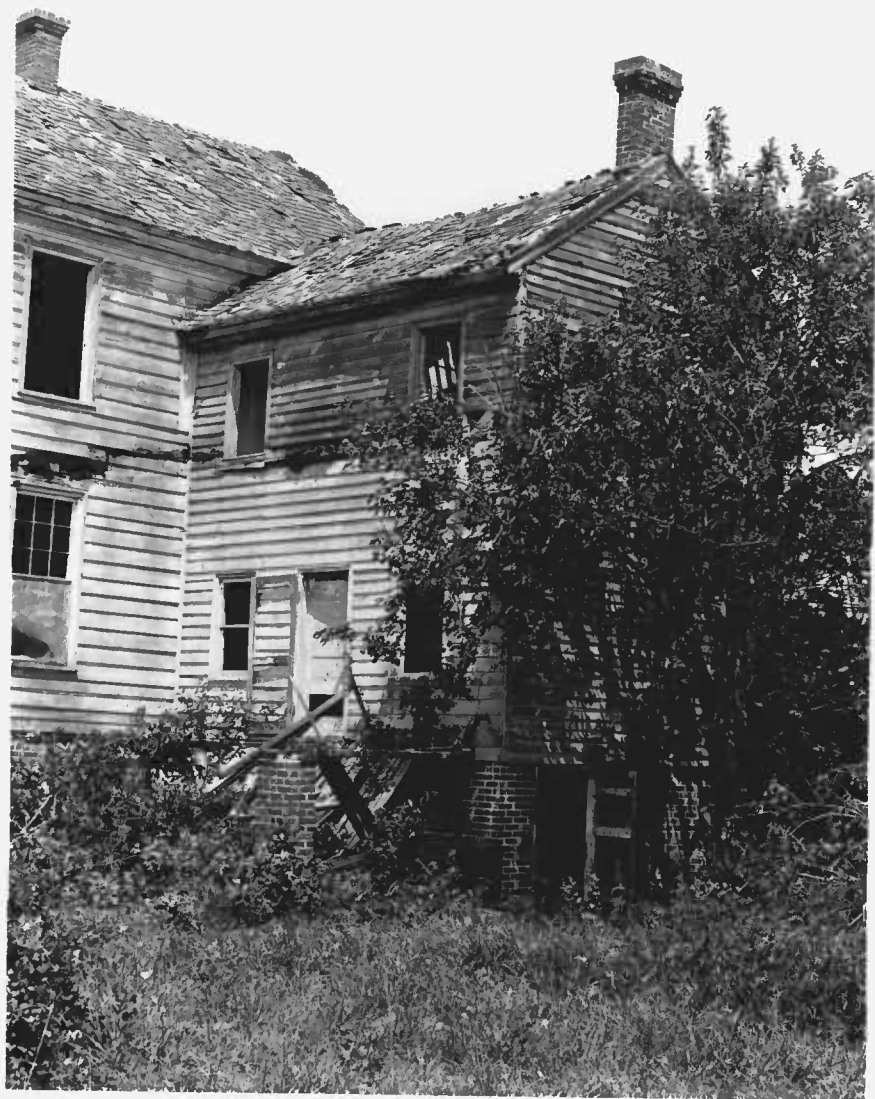
The south side is divided into four bays with each bay marked by a slender six over six sash window on the first floor and six over four sash windows on the second. A three-part window lights the attic. These slender windows were inserted when the original interior and brick chimneys were destroyed and replaced by an interior brick stove stack. Corresponding patches in the flooring and plaster support the former location of the original stacks. The south foundation wall is marked by a six-pane window and a board and batten side entrance door.

Clement Sterling House                      S-291  
Bedsworth Vicinity, Somerset  
South Elevation  
8/85, Paul Touart, Photographer  
Neg./Md. Historical Trust
